Paint Waste Area (PWA) Site History

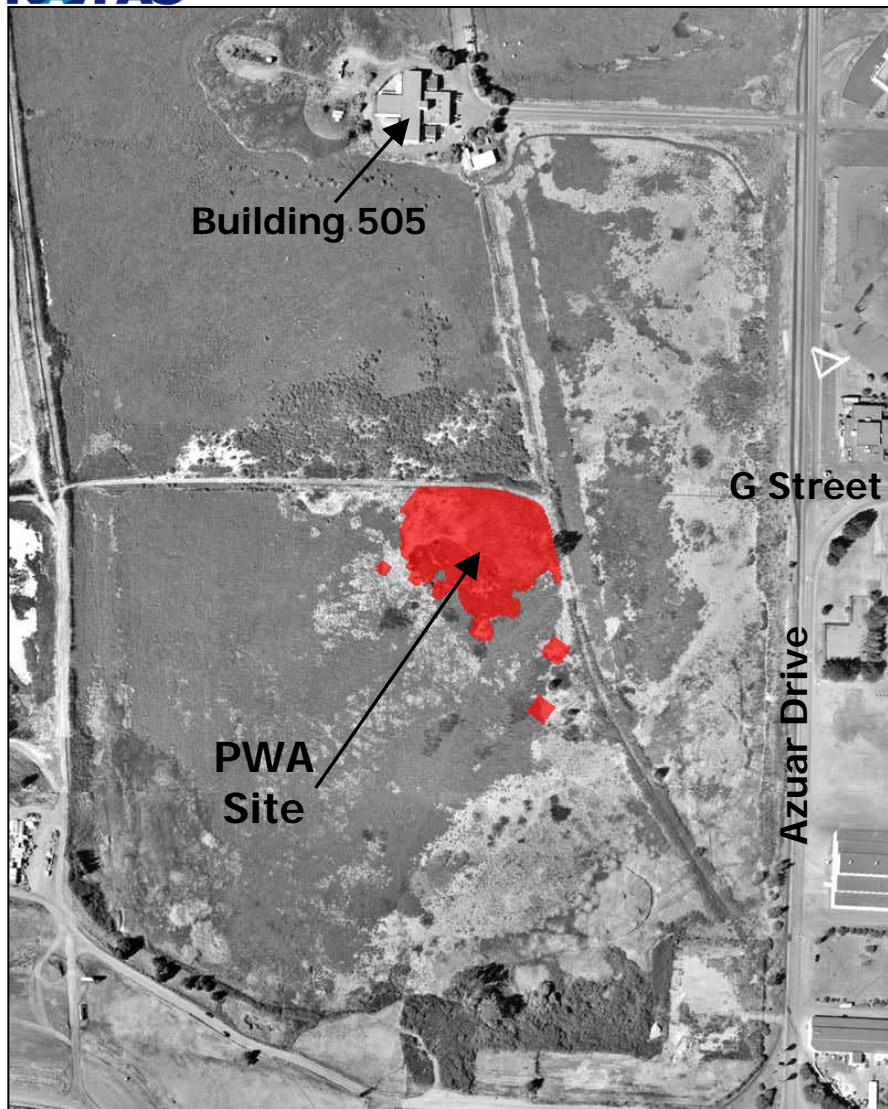
- Located in a pre-WWII dredge fill
- Surface debris led to initial classification as a suspected paint waste disposal site
- Low-level radiological (RAD) items and munitions and explosives of concern (MEC) also encountered
- 2009-2010 – Removal action at 3.6 acres completed
 - 17 MEC and 1,178 RAD items recovered
 - Additional items were found at the perimeter prompting further work in 2011
