## IA-H1 UPLAND HOT SPOT SOIL REMOVAL AND CONSOLIDATION

## IA-H1 CONTAINMENT AREA GRADING ACTIVITIES

## IA-H1 CONTAINMENT AREA GEOSYNTHETICS INSTALLATION AND SOIL COVER ACTIVITIES

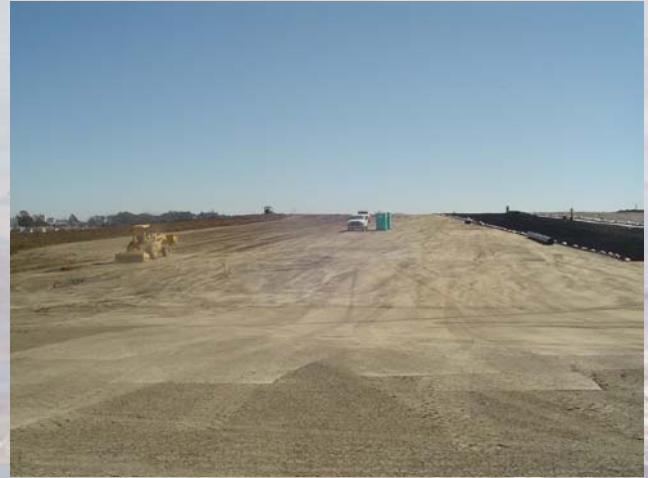
Subgrade preparation prior to installation of geosynthetic layers

WESTON continues to work on grading activities to achieve the design elevations and slopes using soil from the hot spot excavations, Pond 4S soil, and excavated material from the recently approved Time Critical Removal Action for use as subgrade under the cap. The material is transported and placed by off-road haul trucks. A dozer spreads the material into 1-foot thick lifts, which is then compacted with a 20-ton sheepsfoot compactor. Final grading of the subgrade is conducted using the motor grader and a smooth drum roller.

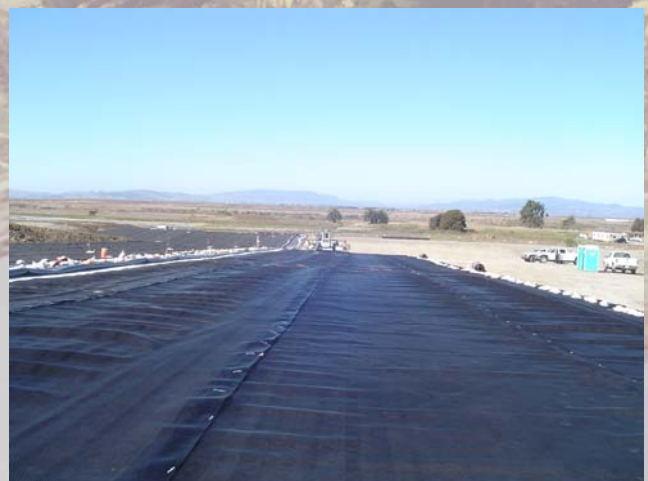
Installation of geosynthetic layers in progress

The geosynthetic cap installation subcontractor is continuing with cap installation activities. To date, 44 of the 72 acre cap (61%) have been completed. The geosynthetic cover system consists of up to four layers depending on the location, including (from bottom to top) a geotextile gas vent layer, geocomposite clay liner, 60-mil high-density polyethylene geomembrane liner, a geocomposite drainage layer, and two-foot soil cover layer which is hydroseeded with native grasses. The work will continue through late December weather permitting.
