Building 84 Update Investigation Area D1.3

**Presented to
The Mare Island Restoration Advisory Board
July 28, 2011**

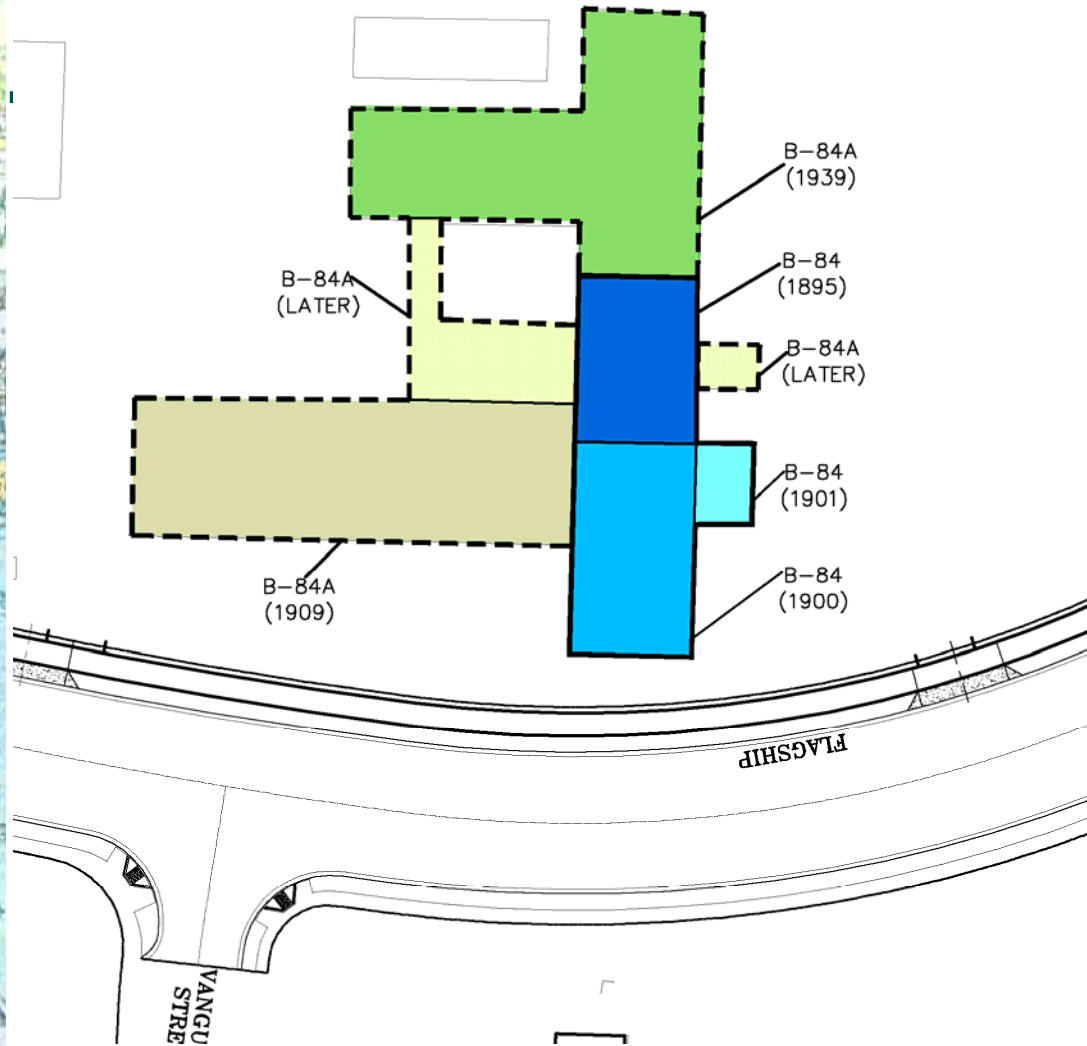
EXISTING SITE PLAN

LEGEND

- BUILDING STR. DATING TO 1885 (B-84)
- BUILDING STR. DATING TO 1900 (B-84)
- BUILDING STR. DATING TO 1901 (B-84)
- BUILDING STR. DATING TO 1909 (B-84A)
- BUILDING STR. DATING TO 1939 (B-84A)
- BUILDING STR. DATING TO LATER PERIOD (B-84A)

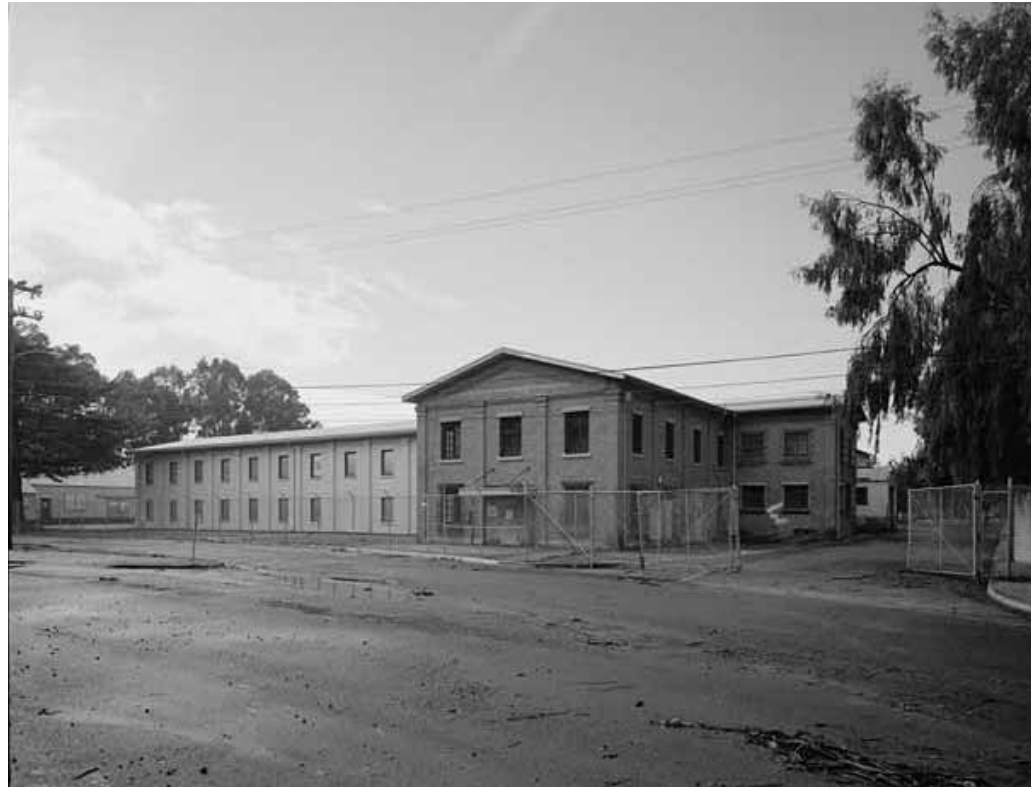
VIEW AS SEEN FROM THE FLAGSHIP DRIVE (NORTH-EAST)

Building 84 dating to 1900 and 1901 to the right in brick; concrete wing Building 84A to the left
